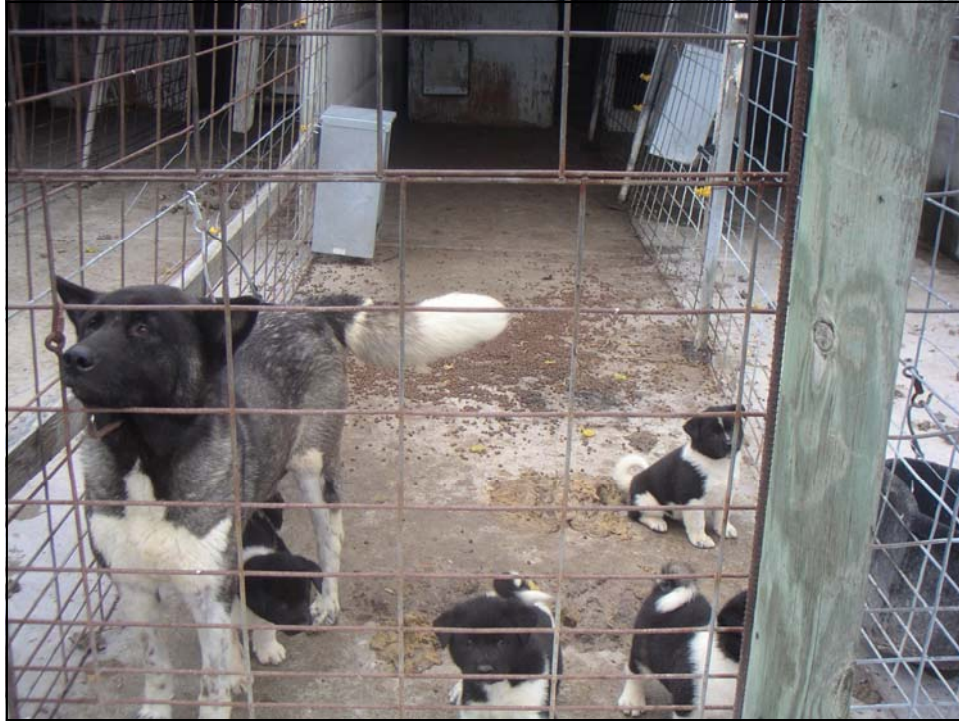
**(Top photo)**

- Wood on dog house has peeling paint (3.1(c)(1) - Surfaces)
- Food scattered on the flooring (3.9(b) - Feeding)

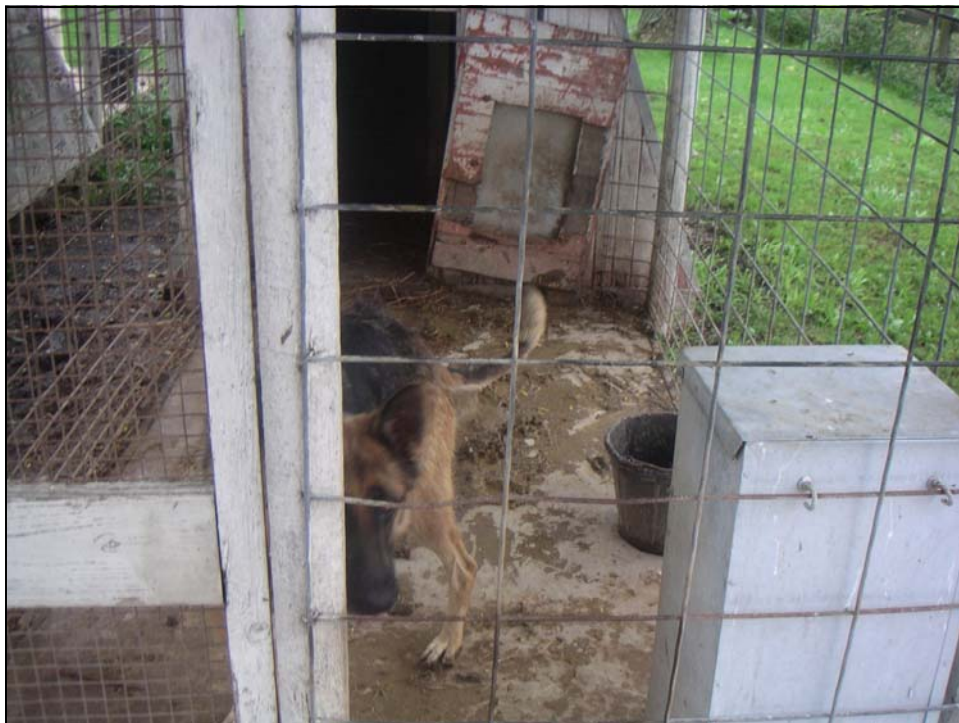
**(Bottom photo)**

- Fecal accumulation (3.11(a) - Cleaning of primary enclosures)
- Dog house lacks windbreak (3.4(b)(3) - Shelter from the elements)
- Wood on dog house door is chewed and rotting (3.1(a) - Structure; construction) and has peeling paint (3.1(c)(1) - Structures)
- Water dish is covered in a dirty build-up (3.10 - Watering)
- Feces is pooled outside of enclosure (3.1(f) - Drainage and waste disposal)

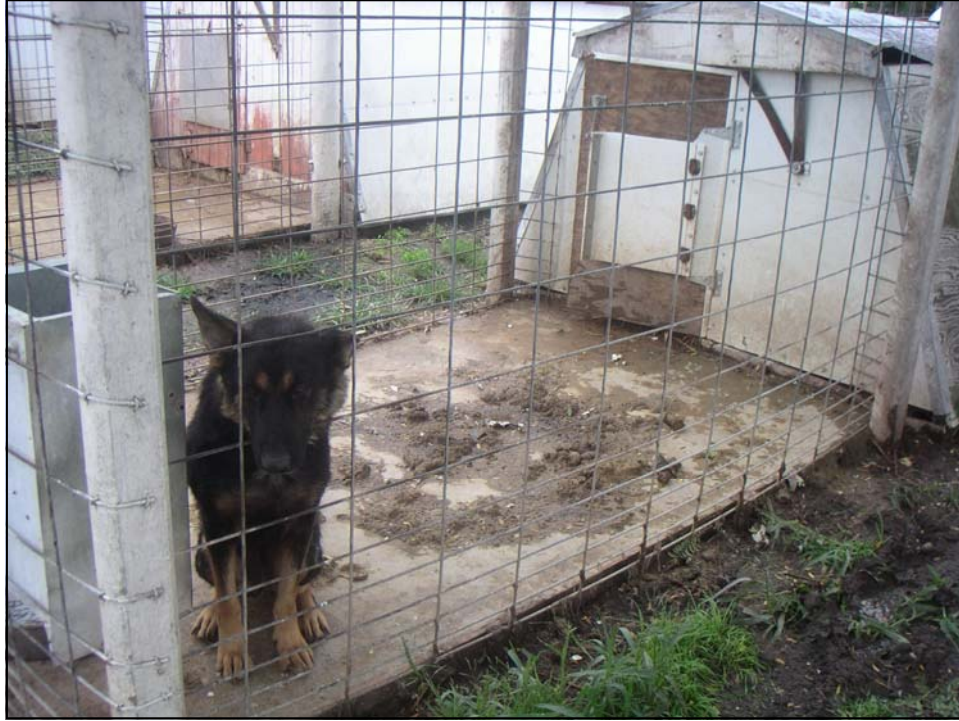
**(Top photo)**

- Fecal accumulation (3.11(a) - Cleaning of primary enclosures)

- Feces is pooled outside of enclosure (3.1(f) - Drainage and waste disposal)
- Wood on adjacent dog house has peeling paint (3.1(c)(1) - Surfaces)

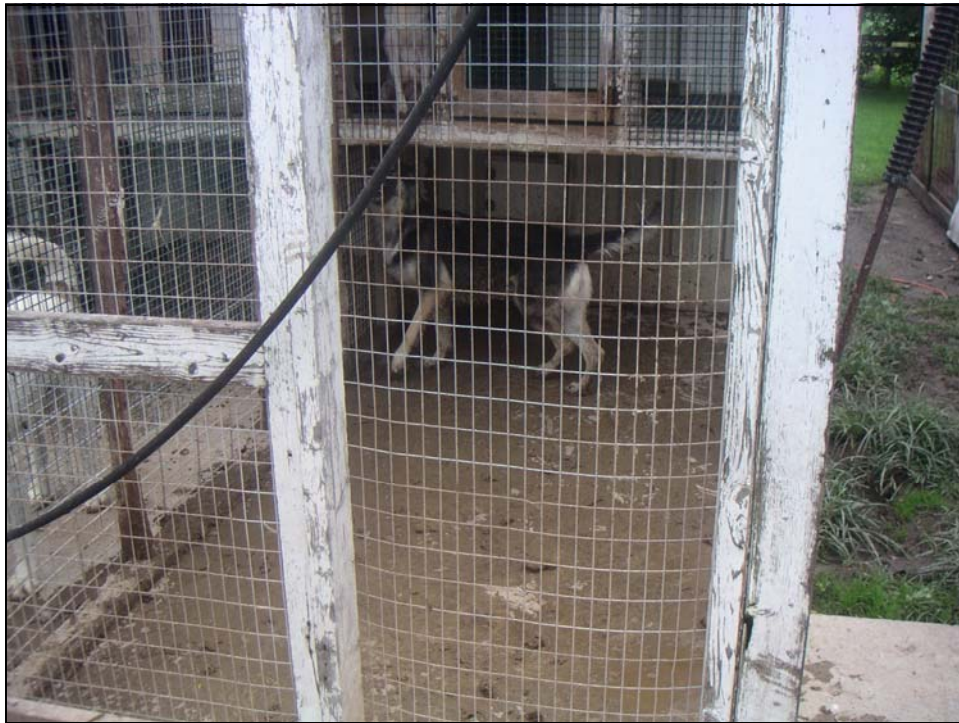
**(Bottom photo)**

- Peeling paint on wooden cage frames (3.1(c)(1) - Surfaces)

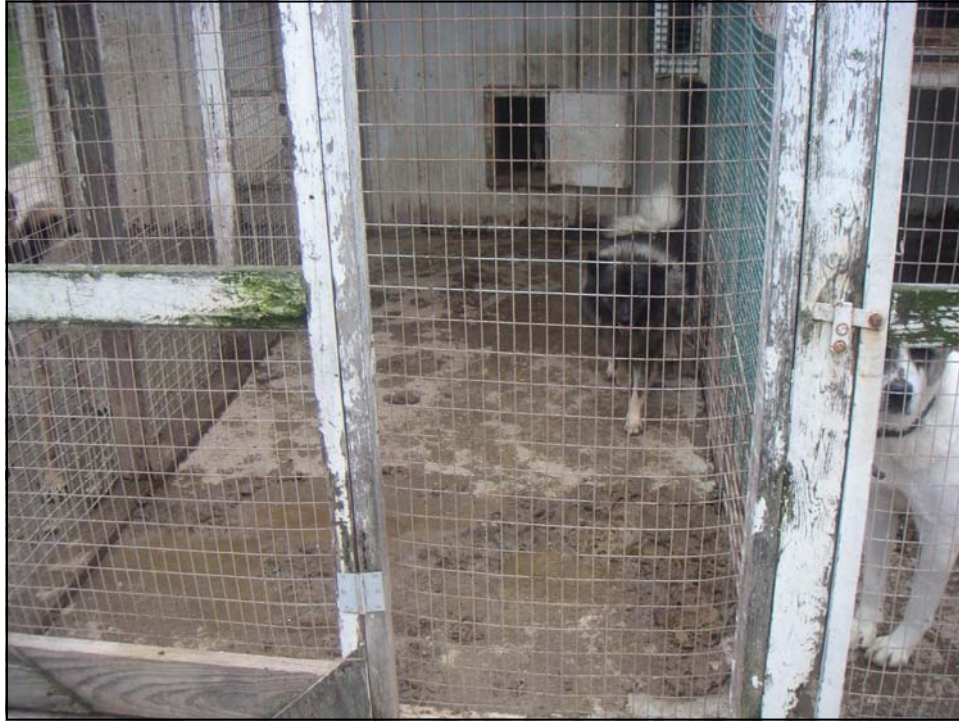
**(Top photo)**

- Fecal accumulation (3.11(a) - Cleaning of primary enclosures)

- Peeling paint/algae on wooden cage frames (3.1(c)(1) - Surfaces)
- Feces stains on wall (3.1(c)(3) - Cleaning)
- Dog door left open (3.4(b)(3) - Shelter from the elements)

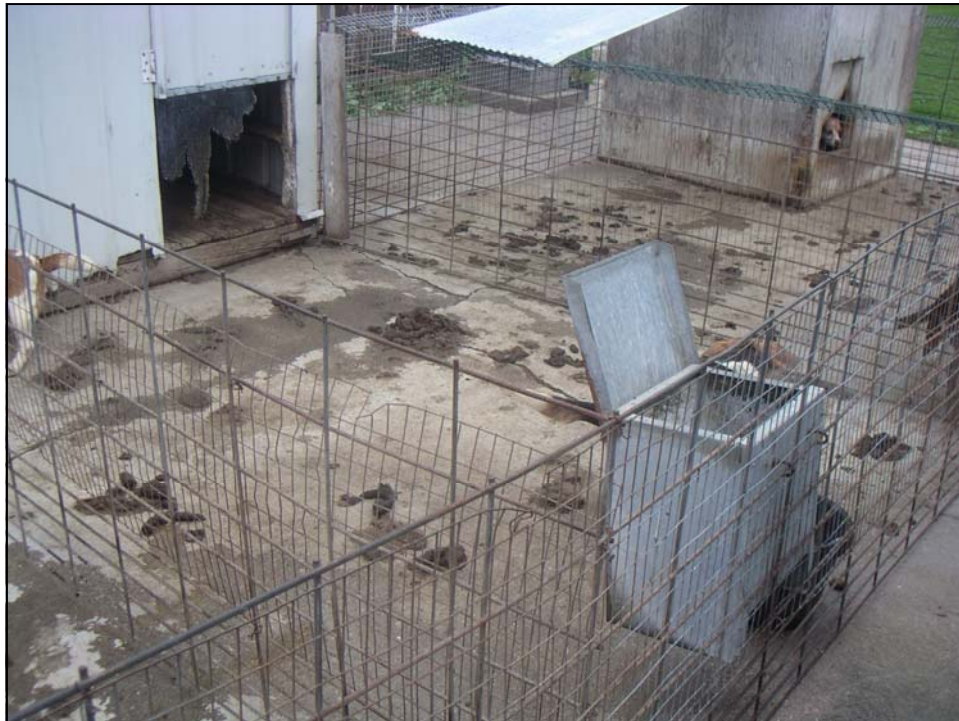
**(Bottom photo)**

- Tattered windbreak (3.4(b)(3) - Shelter from the elements)
- Cracked concrete (3.4(c) - Construction)
- Worn wooden flooring (3.1(c)(1) - Surfaces)

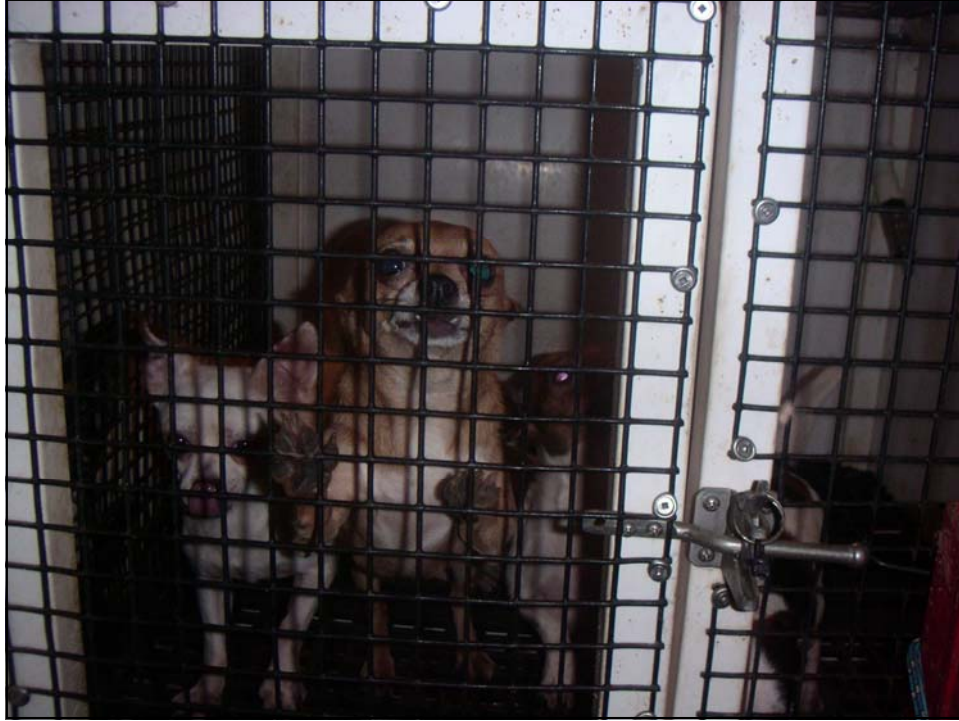
**(Top photo)**

- Insufficient lighting (flash from camera is the only light) - (3.2(c) - Lighting)

- Overcrowded cage (3.6(c)(1)(i) - Primary enclosures)

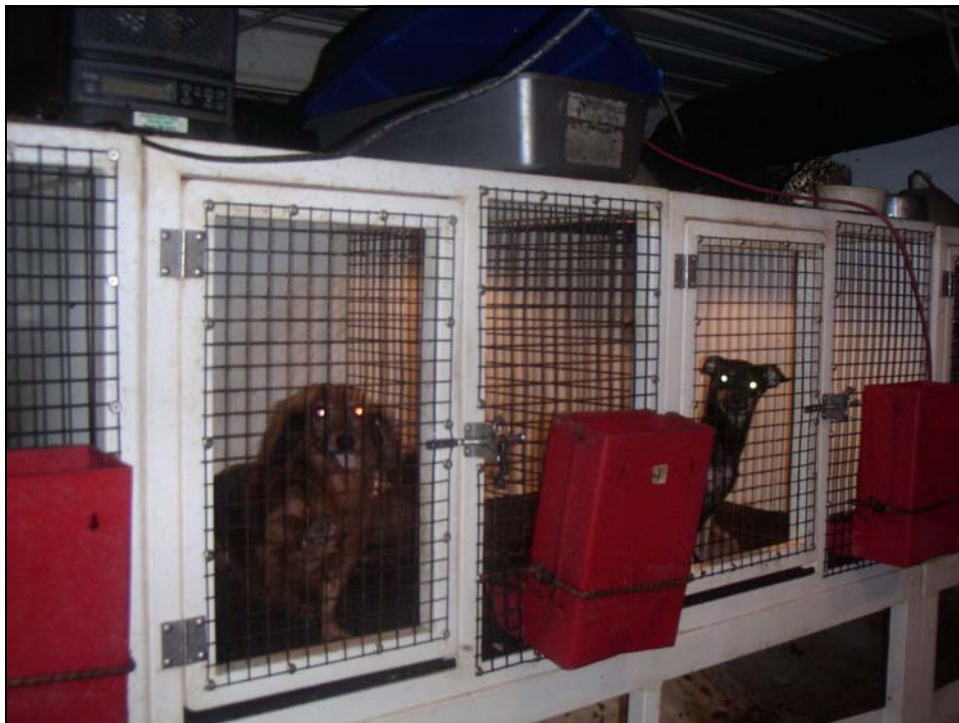
**(Bottom photo)**

- Supplies stored on top of cages (3.1(b) - Condition and site)

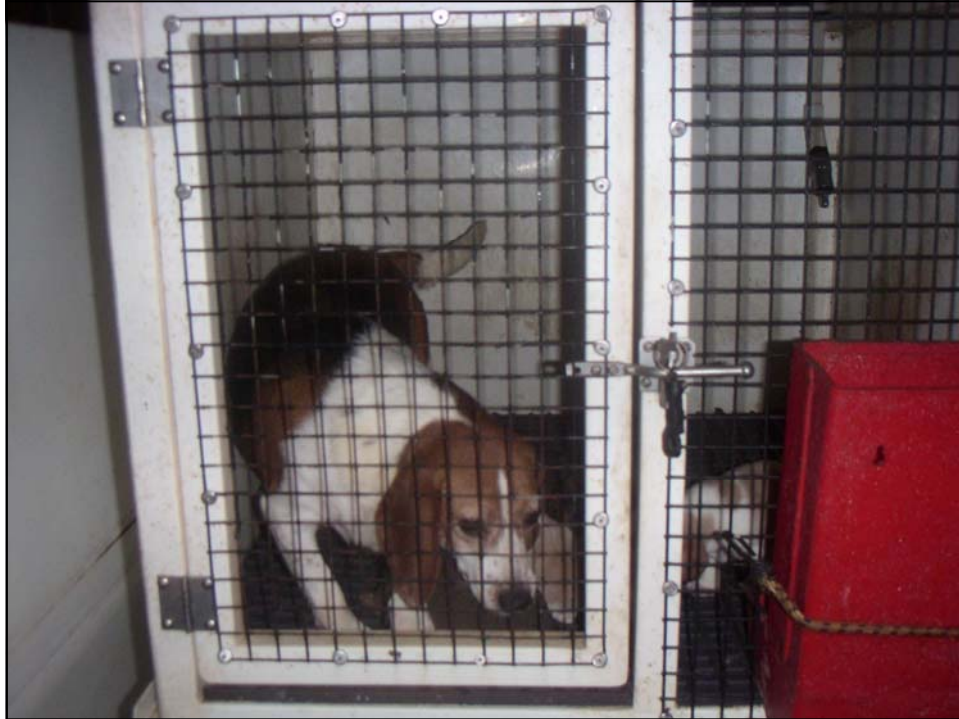
- Stained cage walls (3.1(c)(3) - Cleaning)

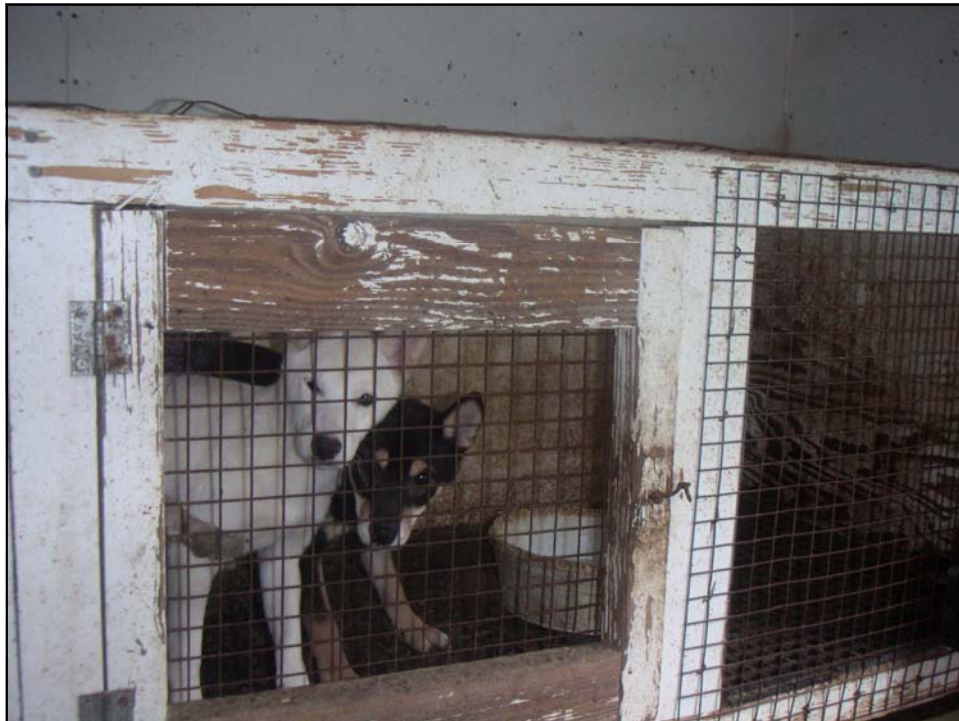
**(Bottom photo)**

- Insufficient headroom (3.6(c)(1)(iii) - Primary enclosures)
- Wooden cage frame has peeling paint (3.1(c)(1) - Surfaces)
- Water dish is stained (3.10 - Watering)

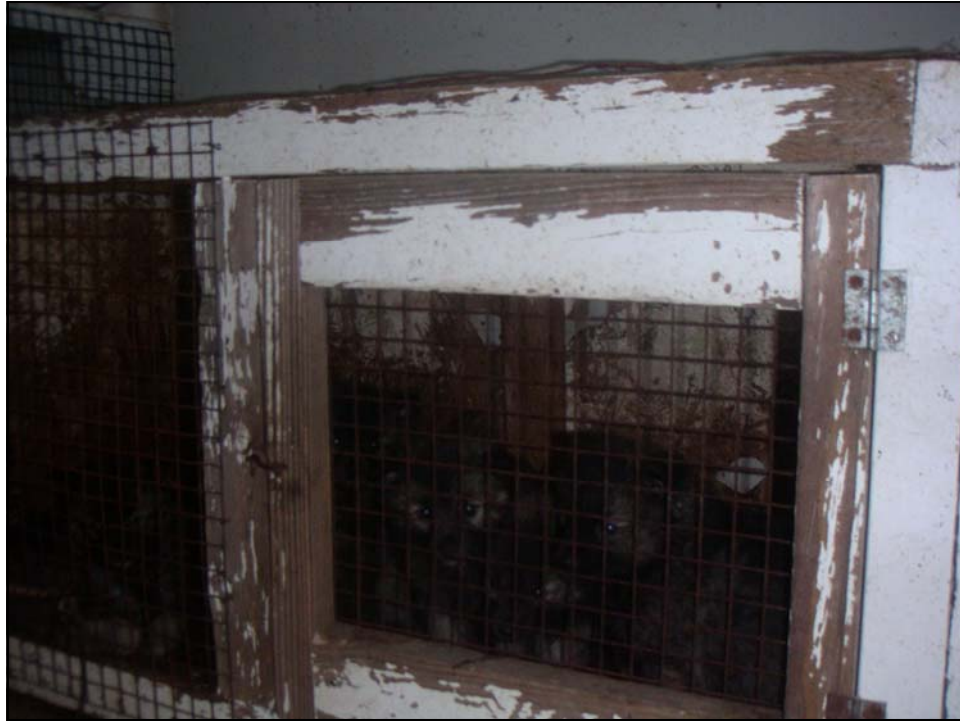
**(Top photo)**

- Wooden cage frame has peeling paint (3.1(c)(1) - Surfaces)

- Insufficient lighting (flash from camera is the only light) - (3.2(c)-Lighting)
- Stained cage walls (3.1(c)(3) - Cleaning)

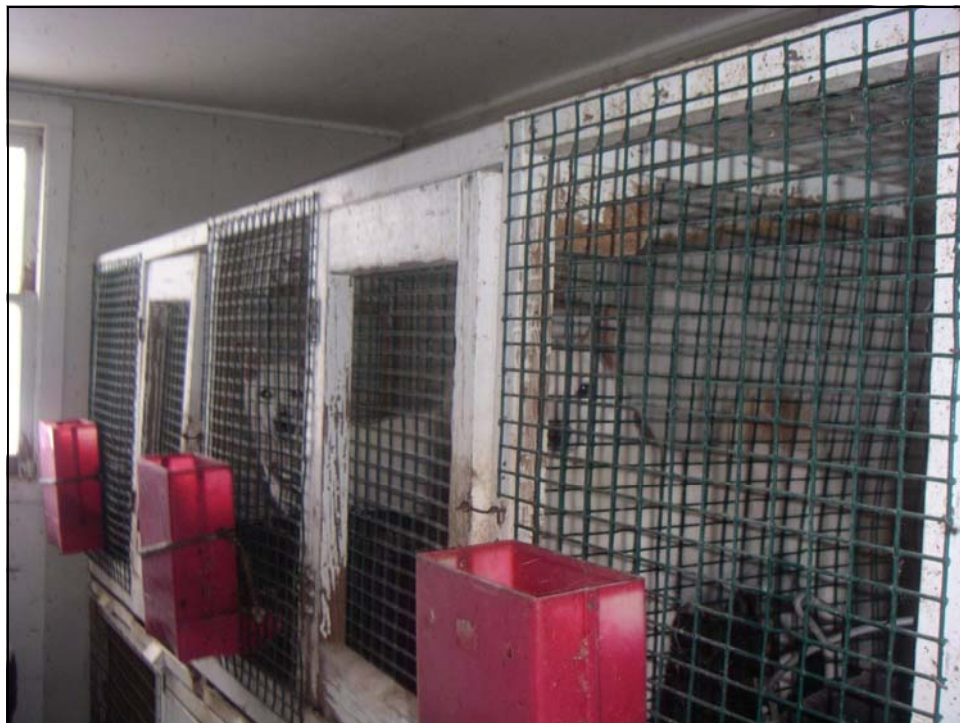
**(Bottom photo)**

- Wooden cage frames are chewed (3.1(a) - Structure; construction)

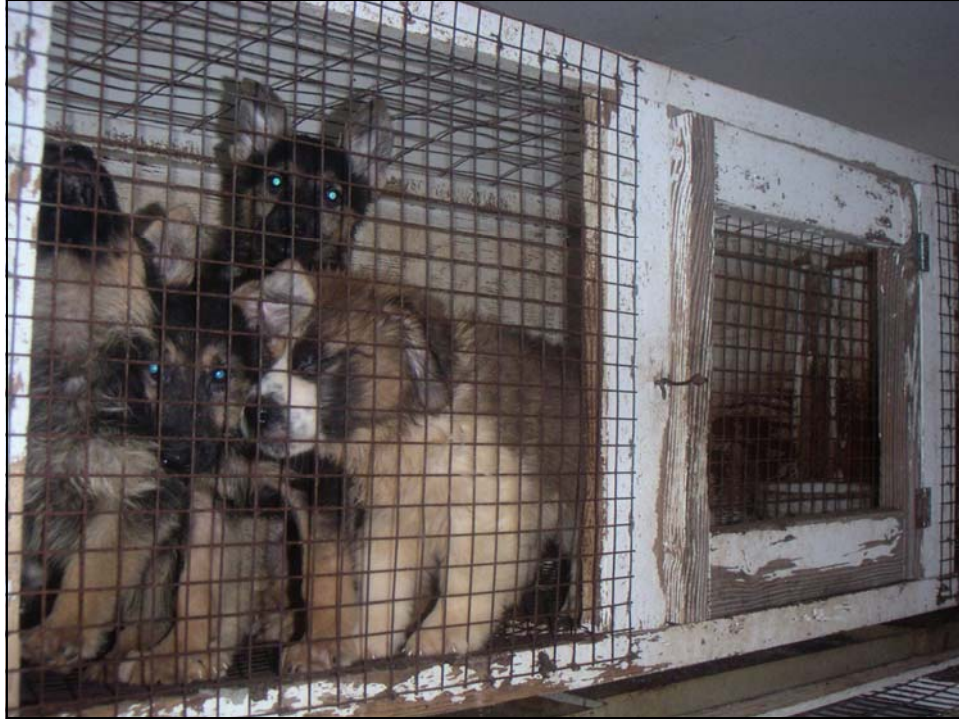
- Overcrowded cage (3.6(c)(1)(i) - Primary enclosures)
- Insufficient headroom (3.6(c)(1)(iii) - Primary enclosures)
- Stained cage walls (3.1(c)(3) - Cleaning)
- Wooden cage frame has peeling paint (3.1(c)(1) - Surfaces)
